PROGRESSIVE COLLAPSE OF STEEL TRUSS BRIDGES, THE CASE OF I-35W COLLAPSE

Abstract: Steel deck truss bridges, being determinate systems and not having redundancy, can progressively collapse over the entire span, if a single primary member or gusset plate connection of the main trusses fails. One of the recent tragic examples of such progressive collapse of the entire bridge due to loss of a single gusset plate is the case of I-35W steel deck truss bridge located in the city of Minneapolis in United States which collapsed entirely on August 1, 2007 resulting in deaths of 13 people and injury to more than 100 others. This paper presents a summary of the structure of the bridge, the condition of the bridge prior to collapse, a likely scenario for its progressive collapse and provides lessons learned and design recommendation in the conclusion section. The recommendations can be used in design of new and in the retrofit of existing steel truss bridges to mitigate this serious life safety hazard.

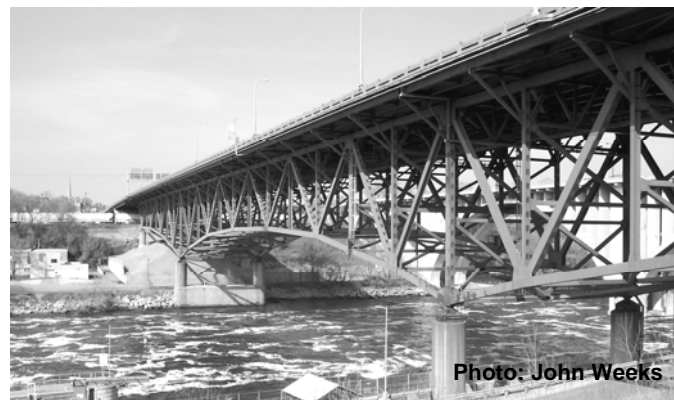
On August 1, 2007 at 6:05PM, in a relatively warm evening, the 40 years old I-35W steel deck truss bridge over the Mississippi River in Minneapolis, Fig. 1, suddenly and without almost any noticeable warning collapsed entirely into the river, Fig. 2, causing the deaths of 13 people and injury to more than 100 others who were crossing the bridge in their vehicles at the time of the collapse.

Fig. 1: A view of the I-35W bridge looking northeast
